Noise assessment of stone/aggregate mines: six case studies

E.R. BAUER AND D.R. BABICH

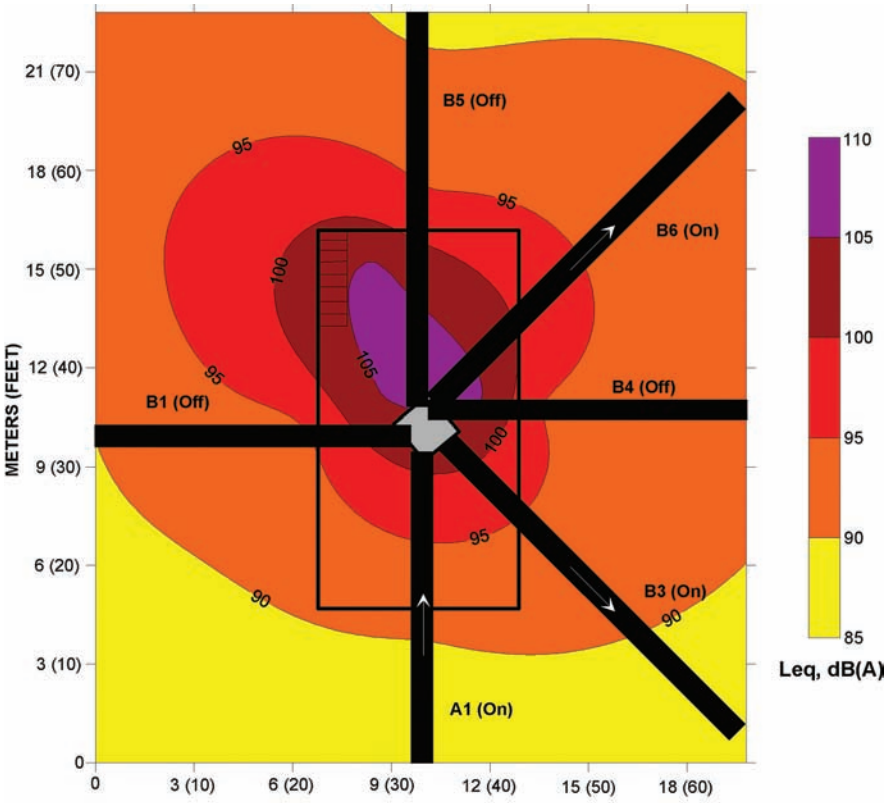
FIGURE 1

Sound profile plot for the primary screening tower.

Equipment and plant sound levels: Table 1 lists the range of sound levels measured around various processing equipment and indicates that the sound levels varied greatly throughout the plants. The highest sound levels were recorded at the primary screening tower, surge tunnel, secondary crusher, secondary screening tower and the fourth level of the agricultural lime crusher. Most of the recorded readings were 93 dB(A) or less. A sound profile plot for the primary screening tower is illustrated in Fig. 1. The measurements ranged from 87 to 96 dB(A) outside the building and 105 to 107 dB(A) inside the screening tower.

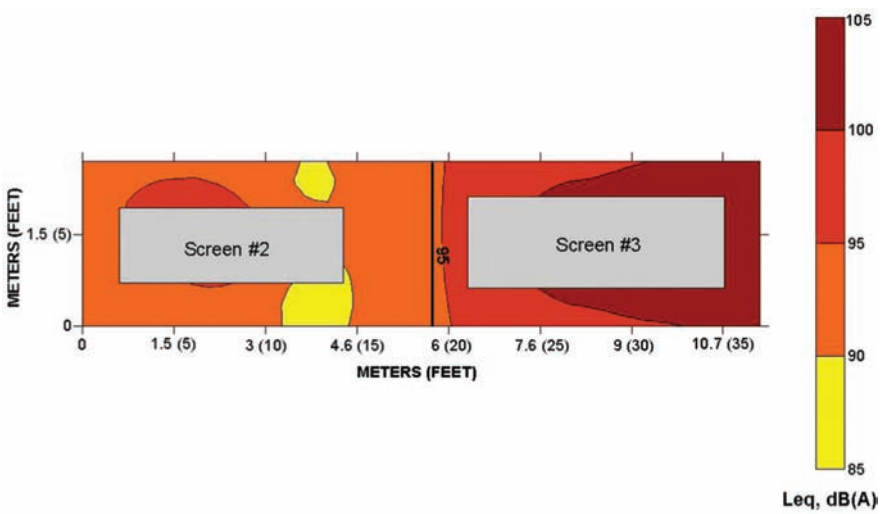
FIGURE 2

Sound profile plot for Telsman screens 2 and 3.

the sound levels measured is illustrated in Fig. 2, which is the sound profile plot for screens 2 and 3 in Plant A. Sound levels from 88 to a little more than 100 dB(A) were recorded.

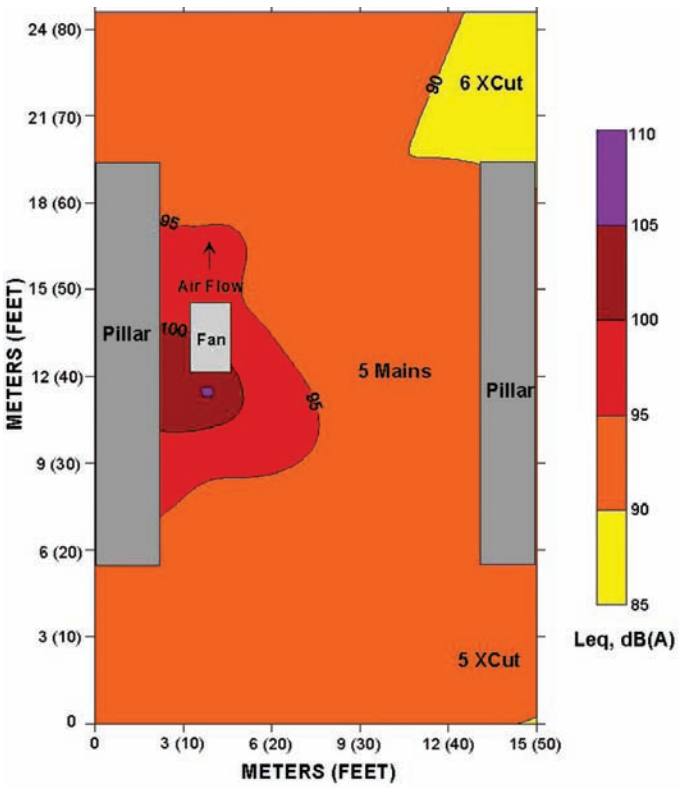
FIGURE 5

Sound profile plot for Joy Axivane 25-hp fan.

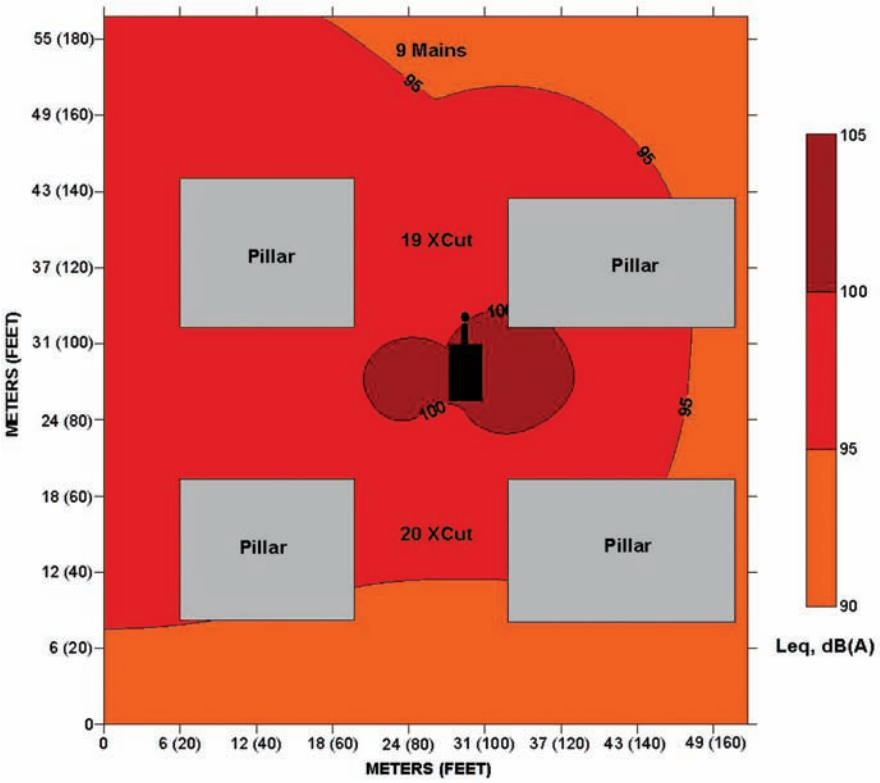
FIGURE 7

The underground face equipment included a Tamrock floor drill and Cannon face drill (both diesel) and a Gradall scaler. Sound levels around these three pieces of equipment were high, ranging from 89 to 103 dB(A). However, the sound level measured inside the enclosed cab of the Cannon face drill was only 83 dB(A). Figures 4 and 5 include a photograph and a sound profile plot of a JOY Axivane 18.8 kw (25-hp) fan. The sound levels near the fan ranged from 90 to 106 dB(A). Another example is illustrated in Figs. 6 and 7, which are a photograph and sound contour plot for a Tamrock Ranger 500 floor drill. Figure 7 illustrates that sound levels up to 102 dB(A) were recorded near the drill.

Sound profile plot for Tamrock floor drill.

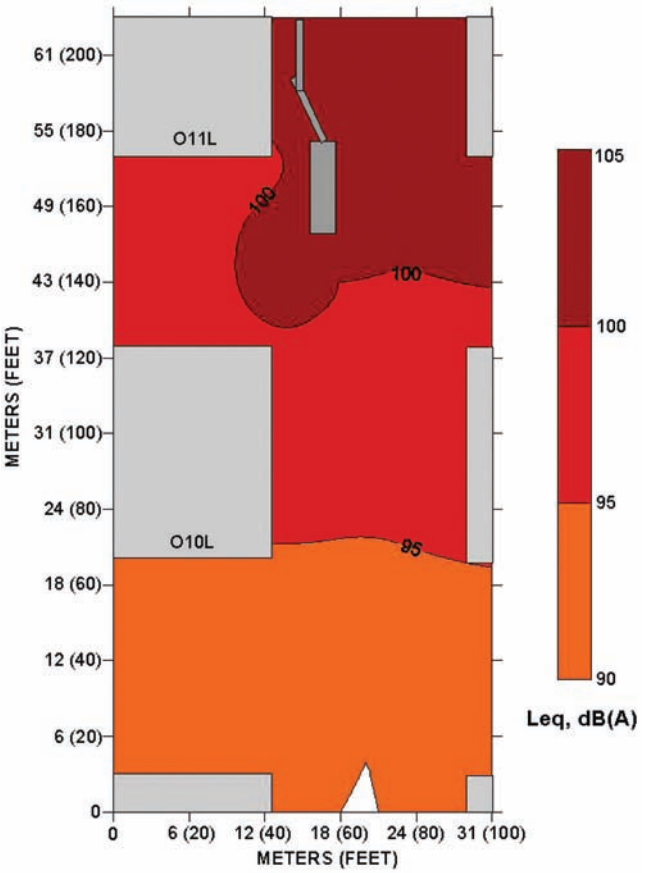
FIGURE 8

the bucket truck and more than 90 dB(A) near the water pump, scaler and face drill. The face drill had the highest measured sound levels, ranging from 86 to 105 dB(A) (Fig. 8). In the processing facilities, sound levels above 90 dB(A) were recorded nearly everywhere except in the jaw crusher control room and at the belt drives (Fig. 9).

Sound profile plot for Gardner Denver MK45H face drill.

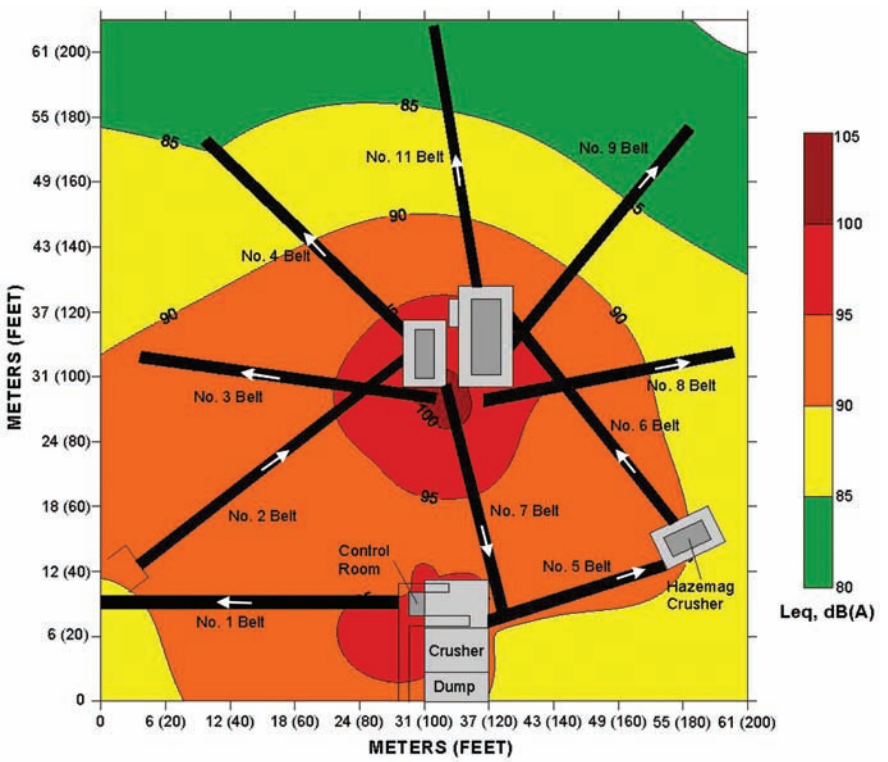
FIGURE 9

Sound profile plot of processing facilities (Bauer and Babich, 2006).
